Figure 1 Image of Royal Crescent elevation

PROJECT DETAILS:

Client	Royal Crescent Society. (representing the 300+ residents of the Crescent)
Listing Status	Grade I group listing, World Heritage Site
Contract Values	£900,000.00 Individual units of £30,000 each
Funding	Individual households and Management companies
Contract details	RIBA Householders Contract
Contractors	Nimbus Conservation (Frome) Corbel Conservation (Taunton) Minerva Conservation (Bradford on Avon)
Type of work	Stonework Cleaning and repair.

PROJECT DESCRIPTION AND APPOINTMENT:

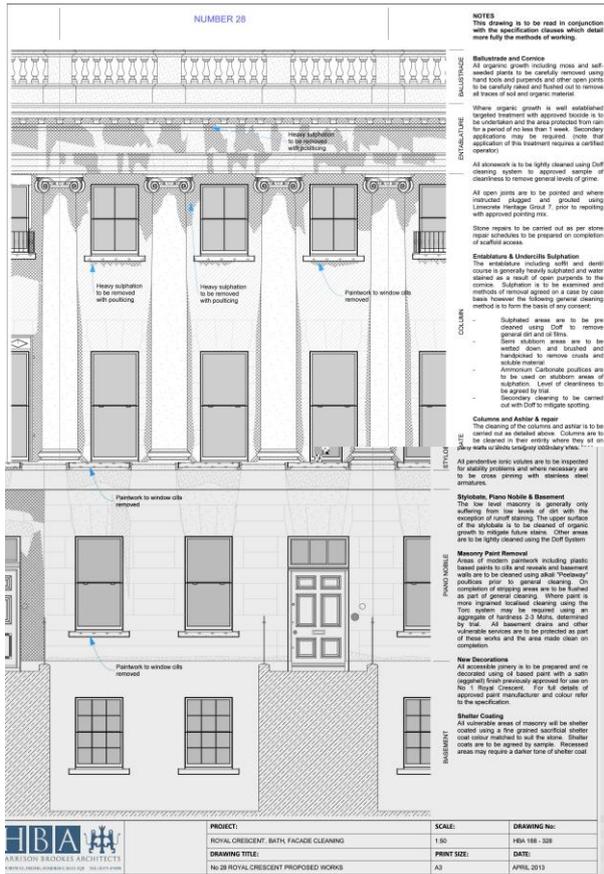
Figure 1 Typical Elevation of house (No 28)

Investigations consisted of two main areas of work. The first was the physical recording of the entire front elevation of the crescent detailing each house in sufficient detail to allow identification of individual stones. This was a significant undertaking & required scaffold access at different ends of the crescent to determine consistency. This enabled base drawings to be produced which were then act as record drawings.

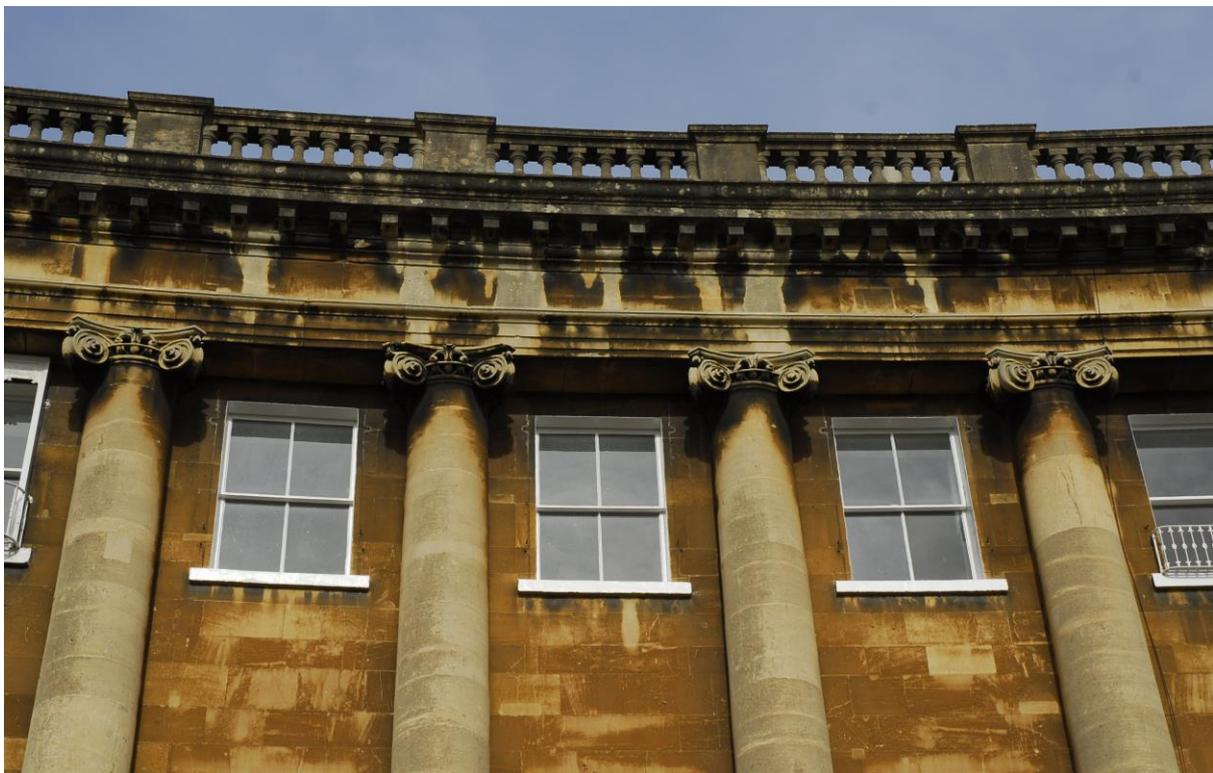
Figure 3 Detail of weathering pattern to elevation

The second area of investigation was a complete inspection of the stonework from the ground using telescopes and long focus lenses to determine the nature of the soiling and weathering. This was a laborious process but allowed a snapshot to be taken of the condition of the entire elevation which was then recorded on the drawings.

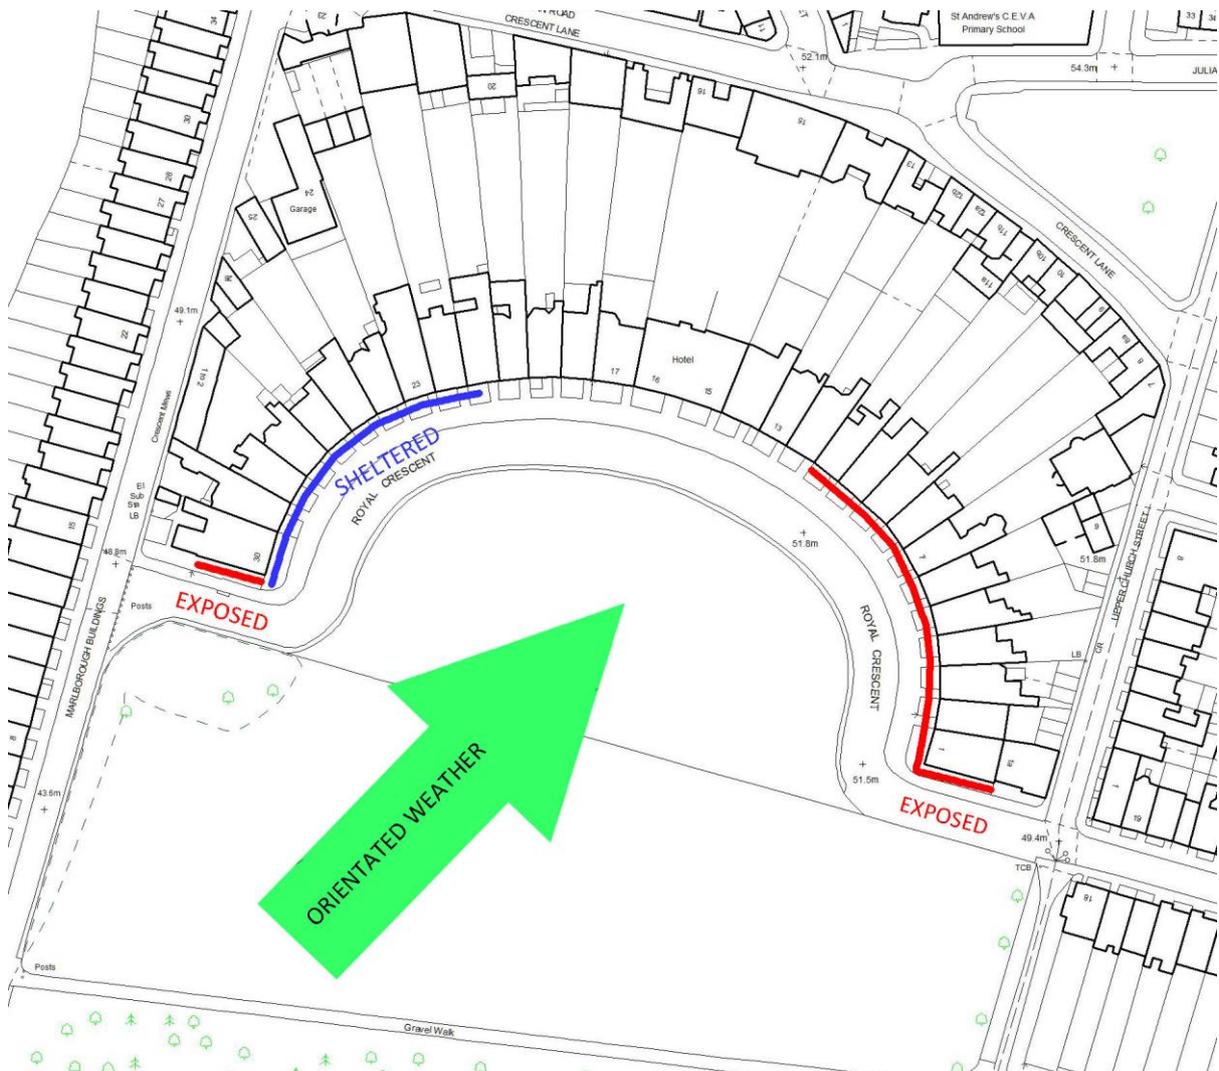
Figure 4 Plan showing orientated weathering

On the large or macro scale the shape and orientation of the crescent has affected its weathering. The prevailing winds and driving rain from the west and southwest has meant that the more southerly and westerly facing part of the crescent (Nos 1-10) shows markedly different patination to the easterly facing buildings (20-30) irrespective of cleaning history. This is very typical of large structures and affects both the runoff characteristics and the sulphation build-up. In its simplest and crudest terms the eastern side of the crescent will be more exposed and therefore less soiled than the western side of the crescent. This principle of orientated weathering, will affect moss, lichen and sulphate buildup, drying patterns, salt leaching and freeze thaw cycles. South westerly facing elements of the building although generally cleaner due to their exposure to the elements can also be more heavily eroded and the stone in a diminished condition. Orientated weathering will also affect individual elements such as columns, and balustrades which have more than one open side resulting in differing patination on the element.

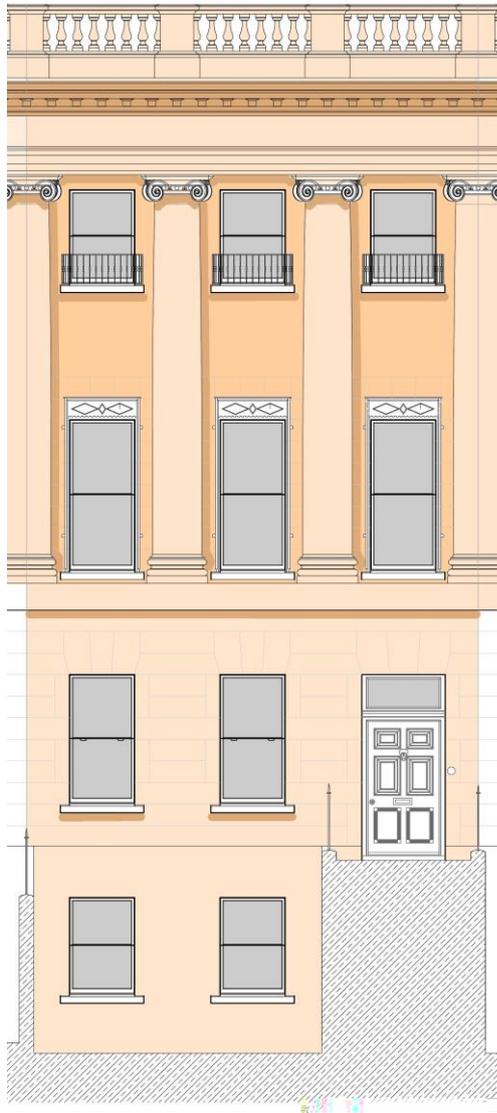
Figure 5 Architectural Planes and Shadows

In the case of the crescent there is a clear correlation between the architecture and the type of weathering. In essence the building resembles the form of a classical temple with the zone between the columns being in-filled. The balustrade the lower entablature the columns and the stylobate and below are all in the same vertical plane. As such they all receive similar degrees of weather and exposure to rain and generally speaking have weathered consistently. However the setback plane of the inter column ashlar is significantly more sheltered and has weathered differently as has the area under the cornice which has weathered most. This difference in weathering in some instances has helped with visual articulation by mimicking shadows, whereas in other areas it has reduced the legibility of the architectural detail.

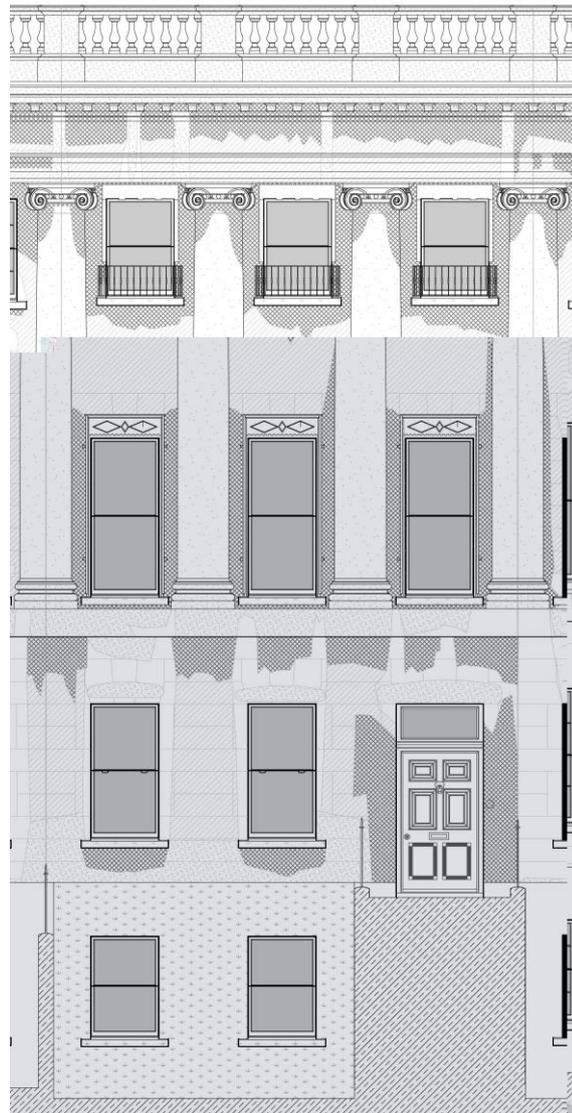
Figure 6 Typical weathering and soiling patterns

In general there are four distinct types of soiling and weathering patterns on the building. The first and most obvious of these is the very dark discoloured areas of the stone. This is caused by sulphur dioxide and other gases mixed with soot particles reacting with the calcium carbonate of the oolitic limestone to produce calcium sulphate based compounds. When thick, this creates a crust or clinker which disfigures the stone and cause significant damage to the stone matrix and legibility of detail. This is generically known as sulphation and tends to form around sheltered or airless areas, especially on architectural details below overhangs and behind columns.

Sulphation can also occur without forming a crust. In this instance the surface of the stone will become “nicotined”. This can happen anywhere but as with the heavy sulphation tends to be in less exposed areas. On balance this type of sulphation is substantially less penetrative and does not disrupt the stone matrix leading to stone failure, although it can be unsightly.

The third distinct area of staining is general air borne grime and dirt. This can build up anywhere but tends to be concentrated in areas of high splashback, runoff, or areas which become disproportionately wet such as columns and balustrades. (The longer an element remains wet the more airborne particles cling to it) The presence of dirt can in turn provide nutrients for organic growth so it is not uncommon to see these areas with green algae bloom, moss, lichen etc.

In addition to the three main forms of weathering there are a group of stains associated with metals such as copper alloys and ferramenta. These are usually associated with fixings which will need to be assessed on an individual basis.

Conversely there may also be areas of leaching on the elevation. This is where runoff has been concentrated over other weathered areas leading to streaking. This is most notable at high level where perpendicular joints have been lost in the cornice or other weathering details.

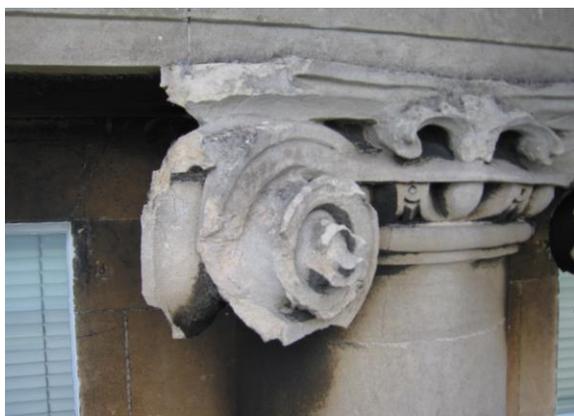
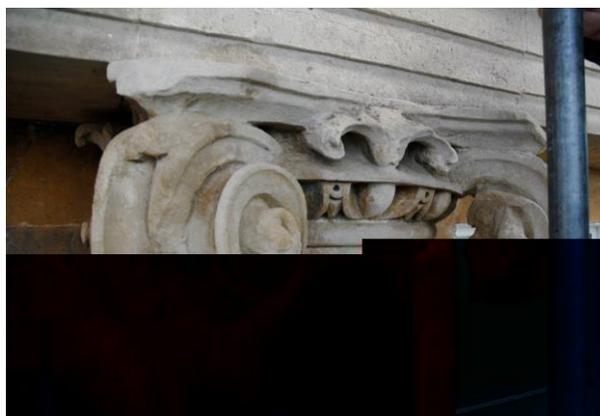
Figure 7 Pre works

Figure 8 Post works

To date four of the 30 houses have been cleaned in the last 18 months with a further group of 5 houses to be cleaned as a single entity next year. The success of the cleaning to a sensitive level is difficult to demonstrate through images as the major impact is in the distant appreciation of the elevation. On a detailed level the two images above showing a before and after cleaning and repair of a column capital, illustrate just how

understated the works have been. This is a typical example of cleaning the column shaft and capital details whilst maintaining an area of slightly soiled ashlar beyond so as not to flatten the elevation.

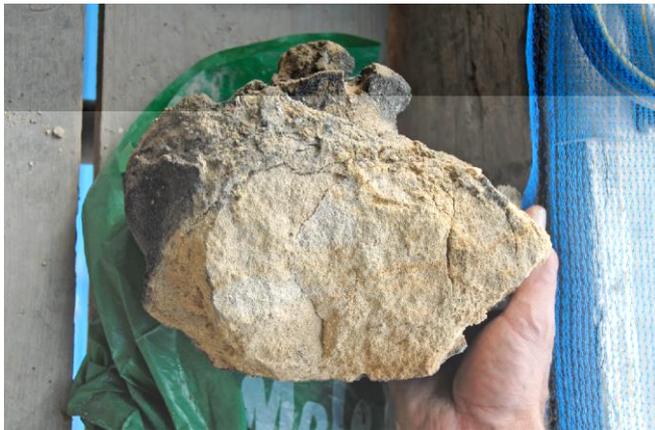
Figure 9 Typical Scroll condition

Repair works have proved more difficult to predict as some buildings, particularly those subject to the prevailing winds and rain have suffered much more than those in the more sheltered areas, and inspection from the ground is no substitute for sounding the stone. This is a direct result of orientated weathering. A key area of discussion on each building has concerned the pendentive scrolls and the balusters. Due to their relief carving these are very susceptible to salt damage and accelerated weathering and a large number have been historically lost and or replaced. Where they are lost this has left the column capitals and balusters often featureless and has significantly eroded the rhythm of the colonnade which is a point of discussion amongst the residents and the conservation officer. This is resulted in a secondary level of philosophy having to be adopted.

Given the classical nature of the building and the clear intention of John Wood, as set out in his lease, that the building is to be maintained to a similar standard across the entire elevation; it was felt that the preservation of the design intent in this instance is more important than the merit of individual stones which have clearly been mass produced. This is a markedly different approach than would be taken on an individual building or a building where records did not communicate the designers original intent.
